PEMBROKE DAM

NH 00377

PHASE I INSPECTION REPORT
NATIONAL DAM INSPECTION PROGRAM

MARCH 1979

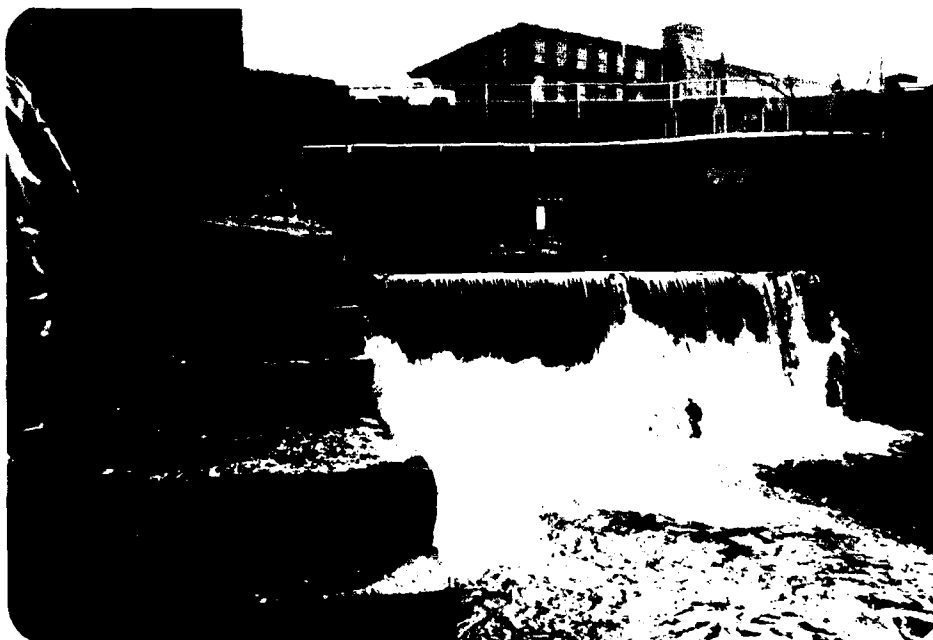
Overview from right side downstream showing
upstream road bridge
